Revised October 2012

Distributor/Dealer Service Instructions for:

## **Safety Recall L16 - Left Tie Rod**

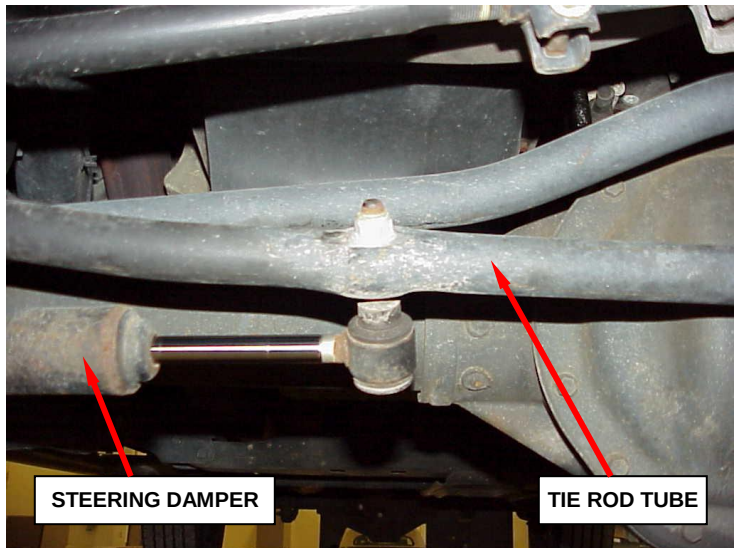
Figure 1 – Steering Linkage

- If the steering damper mounts to the tie rod tube as shown in Figure 1, the steering linkage is good. Continue with **Section D. Tighten Front Track Bar Bolt.**

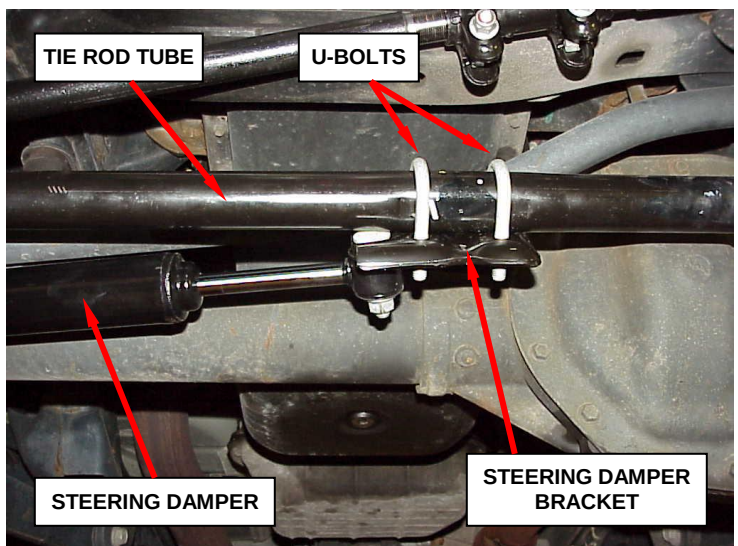
Figure 2 – Steering Linkage

- If the steering damper mounts to the tie rod tube as shown in Figure 2, the vehicle will require further inspection and/or repair. Continue with **Section B. Inspect Tie Rod Angles.**

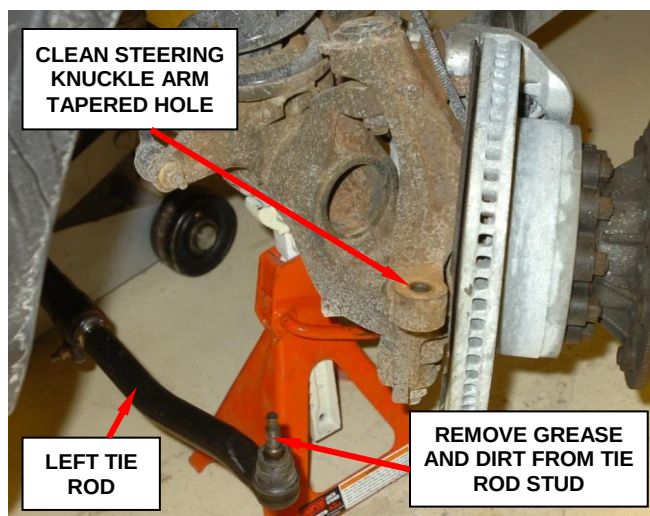
**Figure 8 – Clean Steering Knuckle Arm Tapered Hole and Tie Rod Stud**

**CAUTION:** Failure to clean the steering knuckle arm tapered hole may cause the tie rod connection to the steering knuckle to not seat properly. The steering knuckle arm tapered hole must be clean and dry.

11. Clean the tapered bore in the steering knuckle with Mopar Brake Cleaner (P/N 04897150AB) or equivalent (Figure 8).

12. Remove any grease or dirt from the tie rod stud before installing the stud into the steering knuckle arm tapered hole (Figure 8).
13. Place the tie rod stud into the steering knuckle arm and install the tie rod retaining nut. Tighten the nut to 75 ft. lbs. (102 N·m).

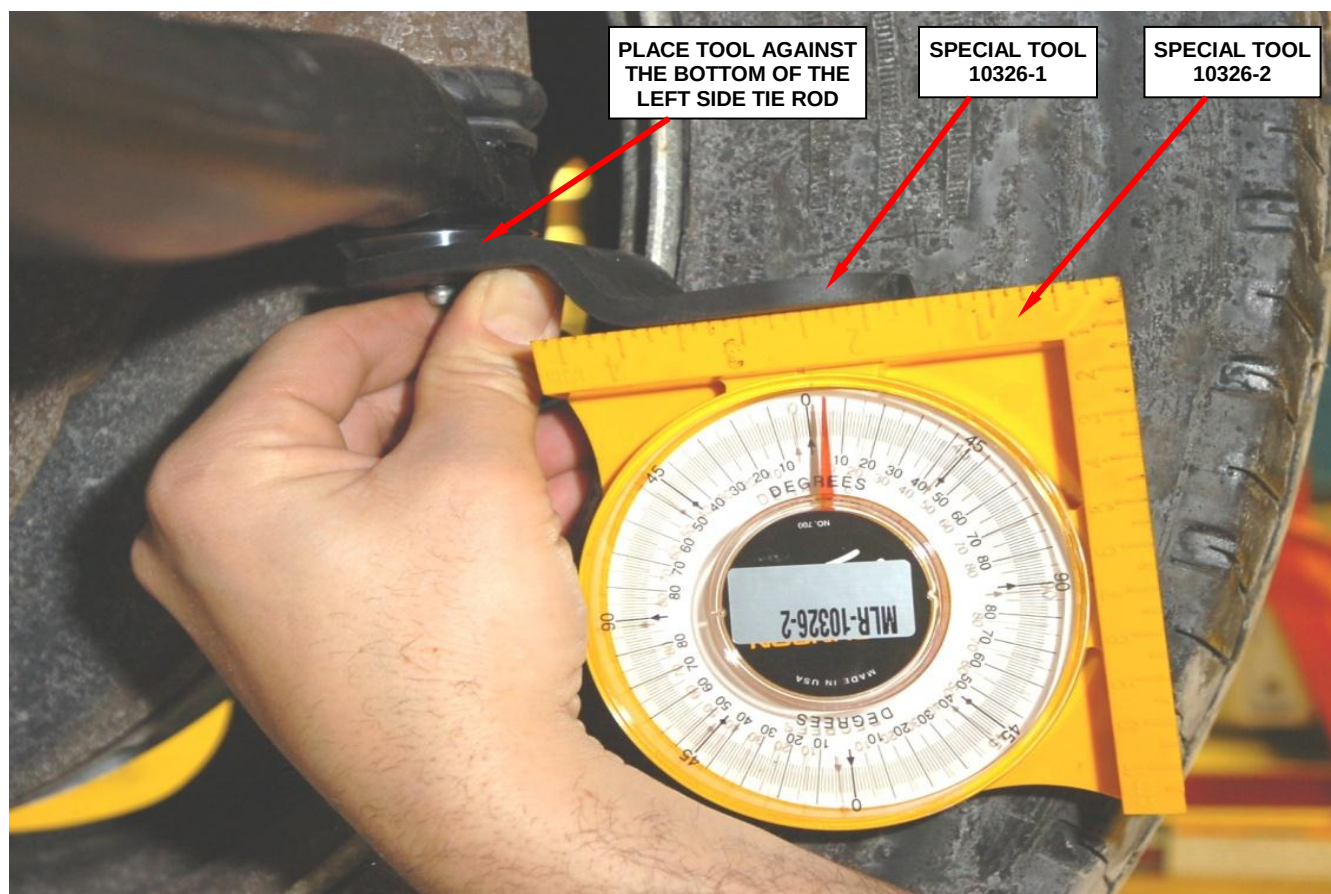
**Figure 10 – Adjust the Left Tie Rod Angle to Match Right Tie Rod Angle**

**WARNING: Failure to have the same right and left tie rod angles will cause the condition this recall is addressing to still be present.**

21. Install Special Tool 10326-1 and 10326-2 onto the bottom surface of the left side tie rod as shown in Figure 10.
22. Adjust the left tie rod so that the same angle appears on the inclinometer gauge as was measured on the right tie rod.

23. Tighten tie rod adjuster clamps to 40 ft. lbs. (54 N·m).
24. Recheck both right and left tie rod angles. The right and left tie rod angles must be the same. If the tie rod angles are different, loosen the left tie rod adjuster clamp and adjust left tie rod as required.

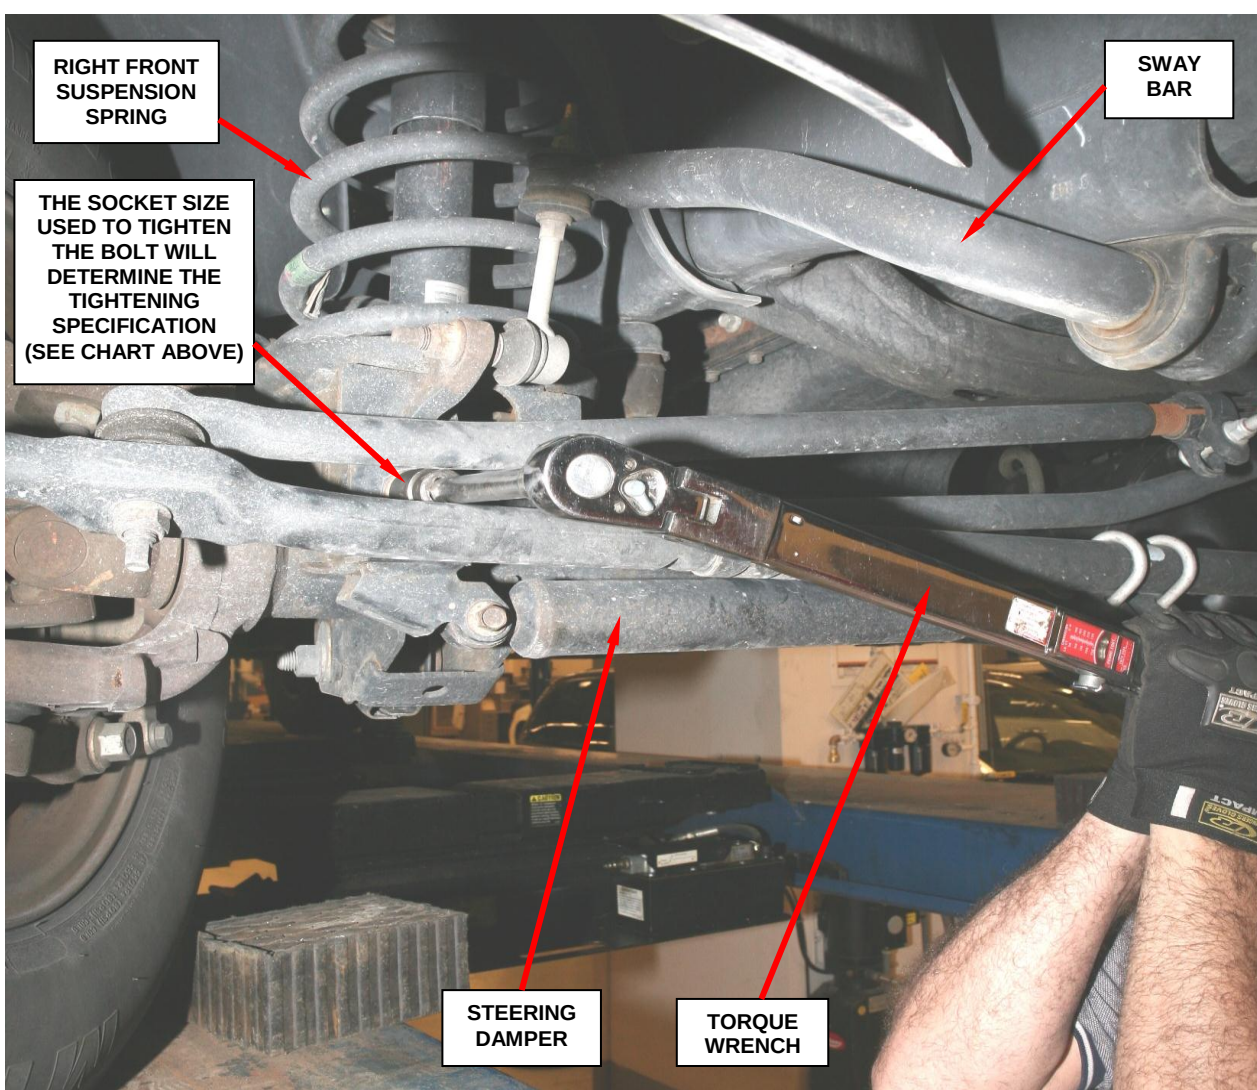
**Figure 11 – Tighten Track Bar Bolt at Axle**

The same vehicles may also have a loose front track bar bolt. This could cause a rattle or banging noise under certain driving conditions.

1. Turn the steering wheel to the full right position.
2. Tighten the track bar bolt at the axle (see chart below for tightening specification).

**NOTE: The vehicle must be on a level surface with full weight on the wheels before tightening the track bolt (Figure 11).**
