# Отзыв по безопасности P77 / NHTSA 14V-796 Гайка шестерни заднего моста — Dodge Ram 1500 2005 года выпуска

**NHTSA** Номер кампании: 14V796

Гайка шестерни заднего моста может ослабнуть на дифференциале

# Отзыв по безопасности P77 / NHTSA 14V-796 Гайка шестерни заднего моста

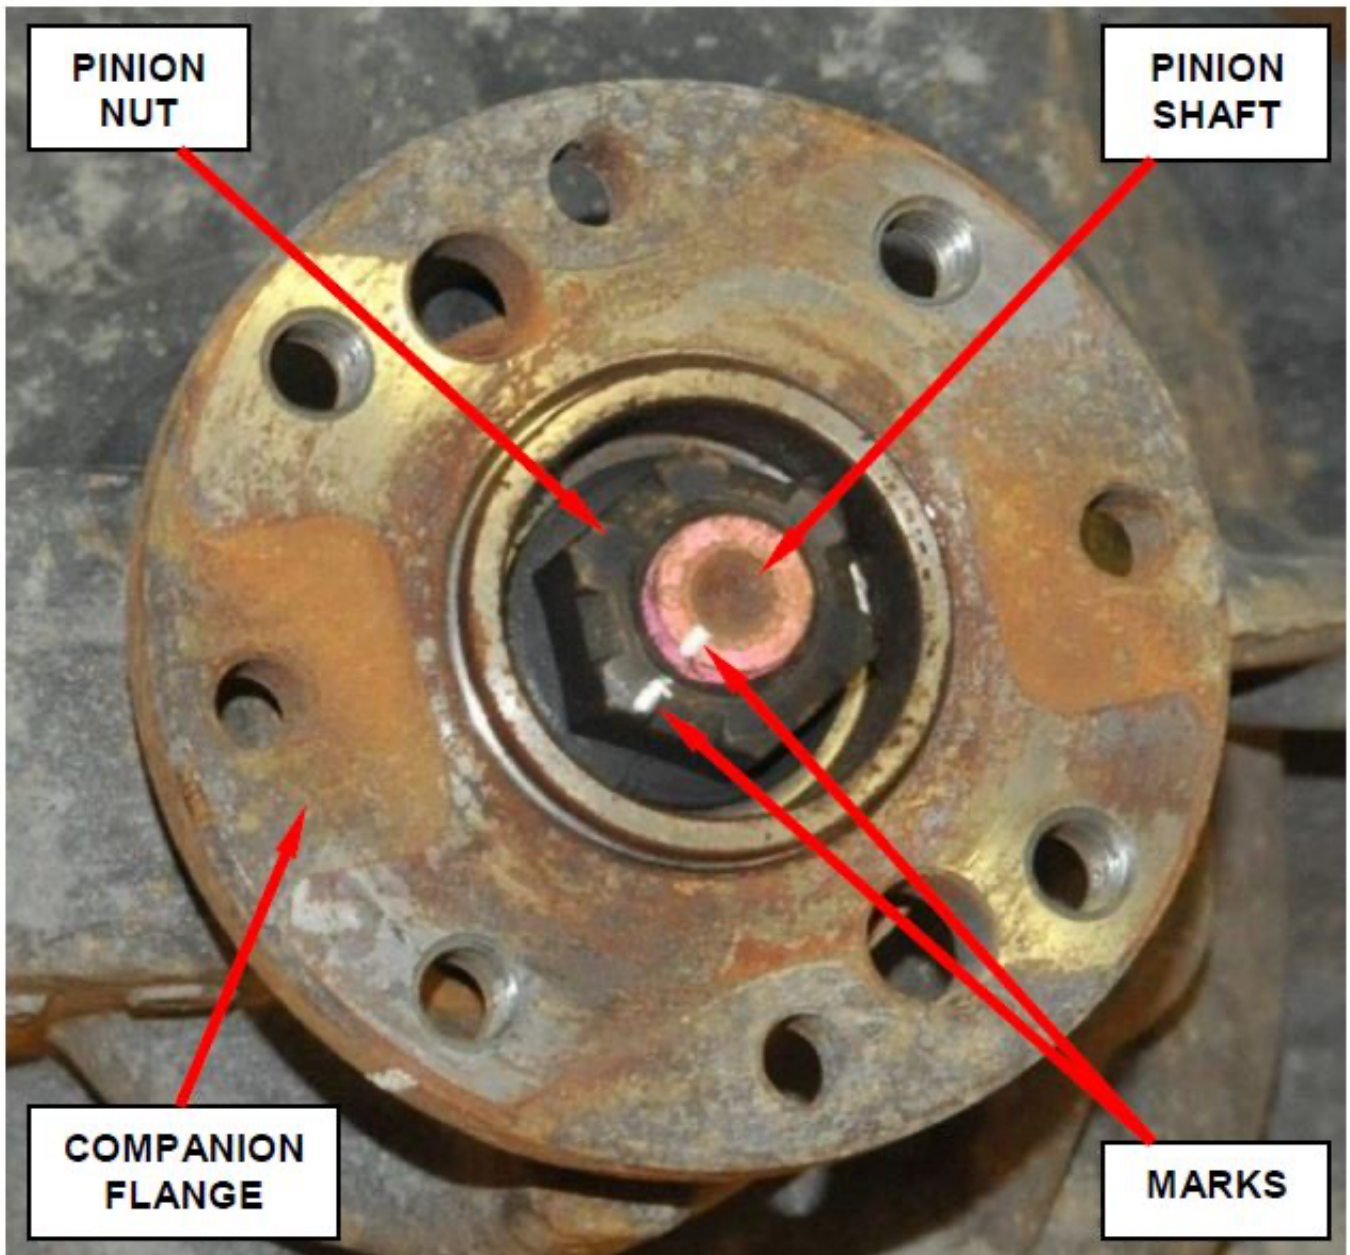
**Рис. 2. Гайка и вал ведущей шестерни**

6. Сделайте отметку на гайке и валу шестерни, как показано на рисунке 2.

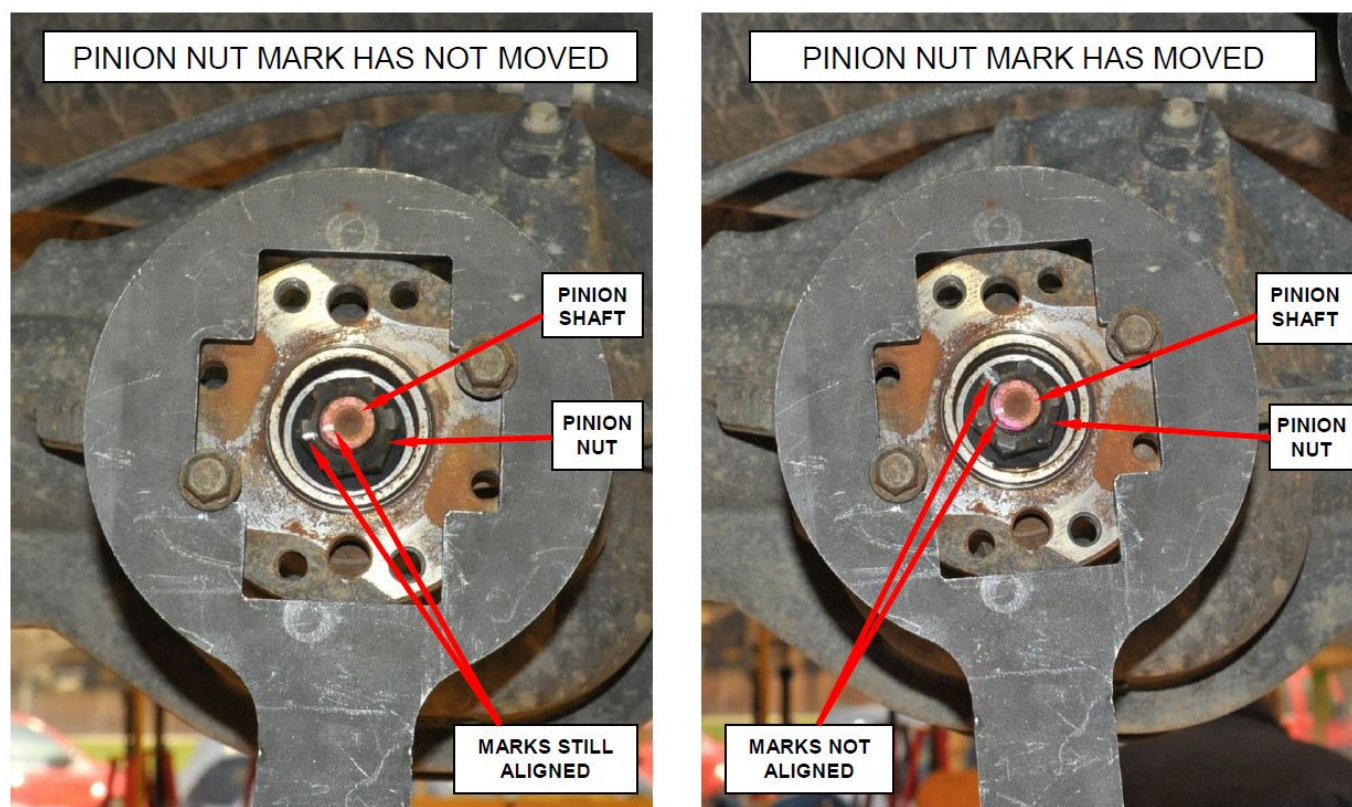
Рис. 5. Проверка перемещения гайки на валу шестерни

- Если метка на гайке шестерни не сместилась (рис. 5), перейдите к **шагу 10 этой процедуры**
- Если метка на гайке шестерни сместилась (рис. 5), кольцо и шестерня должны быть заменены.

- Если метка на гайке шестерни не сместилась (рис. 5), перейдите к **разделу С. Установите стопорное кольцо гайки шестерни.**
- Если метка на гайке ведущей шестерни сместилась (рис. 5), то кольцо и ведущая шестерня должны быть проверены и/или заменены при необходимости.  
Продолжайте работу в соответствии с **разделом В. Восстановление заднего моста.**

Продолжайте работу в соответствии с **разделом В. Восстановление заднего моста**
