## 8-SPEED TRANSMISSION SERVICE

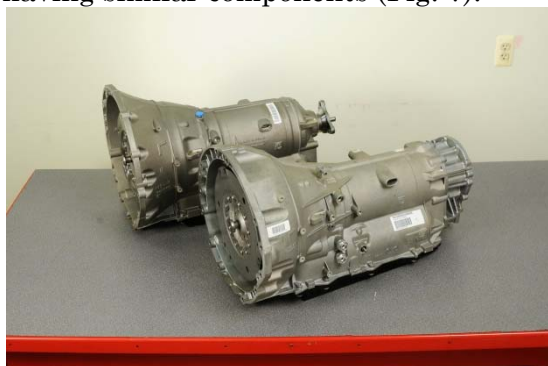
The 8HP70 looks similar to the 8HP45, being almost the same length, even having similar components (Fig. 7).

**Figure 7:** 8HP70 Rear, 8HP45 Front

While a few parts are interchangeable, most are not. The 8HP70 is a larger, heavier-duty version of the 8HP45.

Due to the increased size, you'll find the majority of the internal components such as rotating components, the case, and output shafts (among others), are not interchangeable. The majority of the service tools, as well as diagnostics, are common between the 8HP45 and the 8HP70.

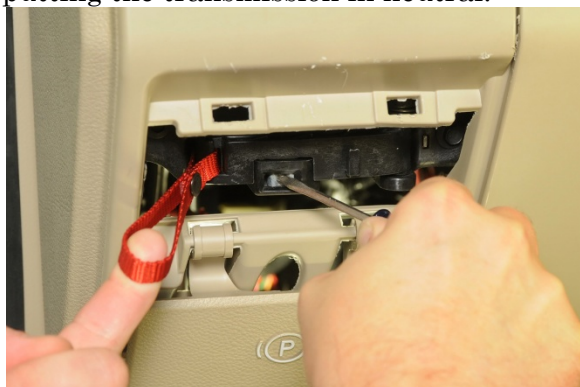
The Ram 1500 has the release behind this trim panel, above the parking brake release handle. To manually release the park lock, push this lock aside before pulling on the red strap (Fig. 8). The lever will latch into the unlock position, putting the transmission in neutral.

**Figure 8:** Slide the Lock to Release the Park Release Lever

After sliding the lock to the side again, the lever will snap back into place, putting the transmission back in park.

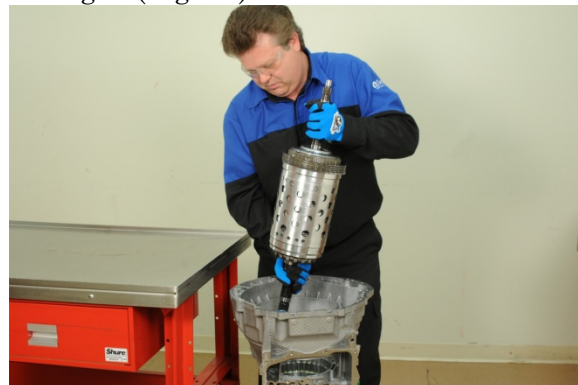
When disassembling the transmission, it's important to note that the gear train needs to be removed vertically. The drums are aluminum and are easily damaged (Fig. 12).

**Figure 12:** The Gear Train Must Be Removed Vertically

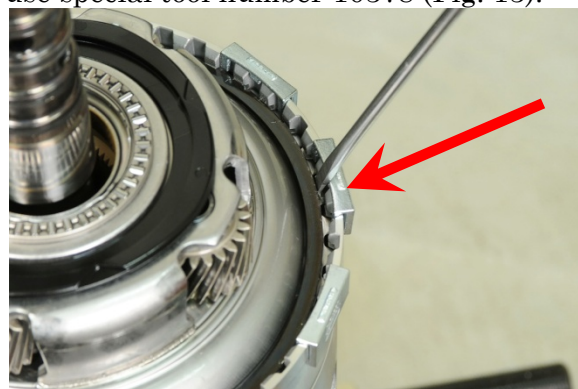
To avoid damaging the aluminum D clutch drum and the P4 annulus drum, use special tool number 10378 (Fig. 13).

**Figure 13:** Special Tool Number 10378
